**Mechanical Damage Inspection Using MFL Technology**  
**Agreement DTRS56-02-T-0002**  
**4th Quarterly Status Report**  
**Period July 1 to September 30, 2003**  
**Contractor: Battelle**

The goal of this project is design an improved magnetic flux leakage inspection system for mechanical damage. This status report describes the magnetic finite element modeling of the high and low field magnetizer. To evaluate design improvements, a model of a standard two magnetizer system was established. This two magnetizer design, illustrated in Figure 1, is technically feasible to apply the dual magnetization technology developed in the prior program, but has not been commercially accepted because it increases the size of the tool to unacceptable lengths.

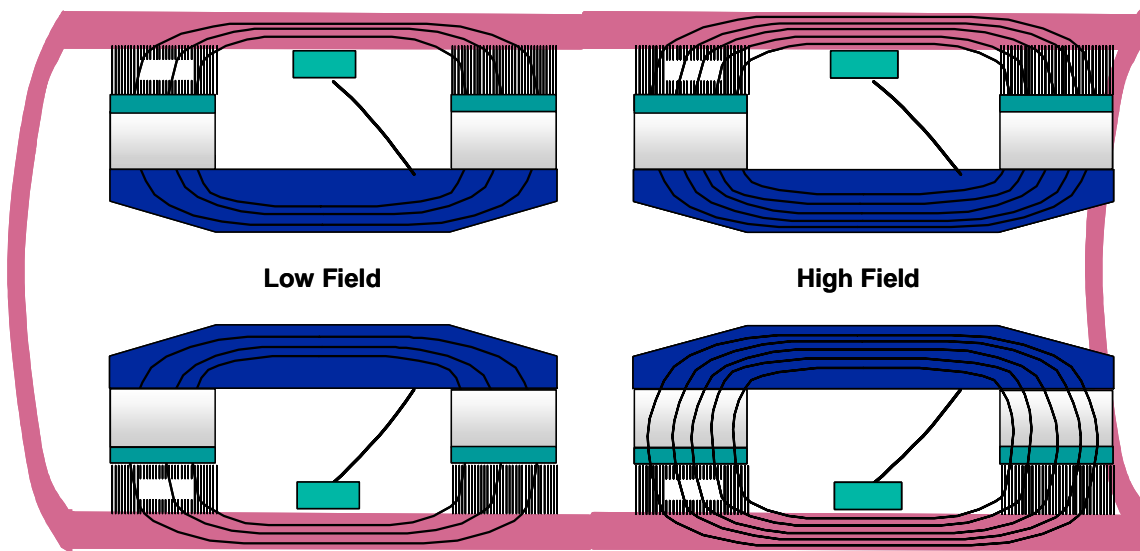
**Figure 1. Two-magnetizer implementation of mechanical damage inspection technology.**

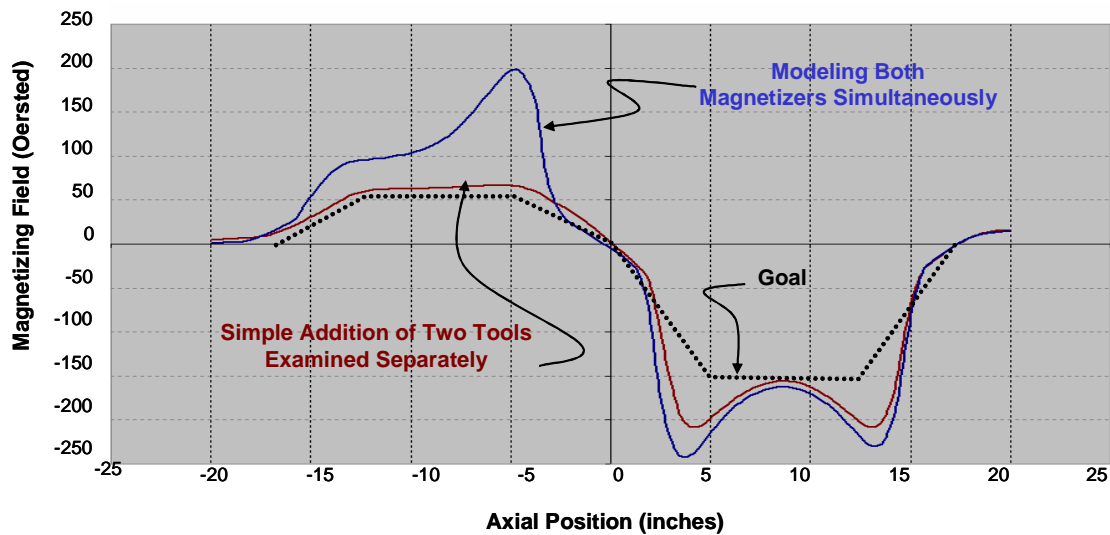
**Figure 2. Model results for a two-magnetizer implementation of mechanical damage inspection method**

When implementing this design, care must be taken to ensure one magnetizer has minimal effect on the other. This is illustrated in Figure 2. The goal of the dual magnetization inspection technology is to inspect at a high magnetization level, between 120 and 160 Oersted and a low level, between 50 and 70 Oersted. To attain consistent signals, a zone of constant magnetization over several inches is desired. If the two magnetizers are far apart, the design goal is nearly met with a large zone of constant magnetization at low magnetization and a smaller but adequate zone at high magnetization. Because the pipe is near magnetic saturation at high magnetization levels, a long zone cannot be attained. However, when the two magnetizers are placed next to each other, interactions occur. As illustrated in Figure 2, the low field slightly increases the high

field, but more importantly, the high field distorts the zone of constant magnetization for low magnetization levels.

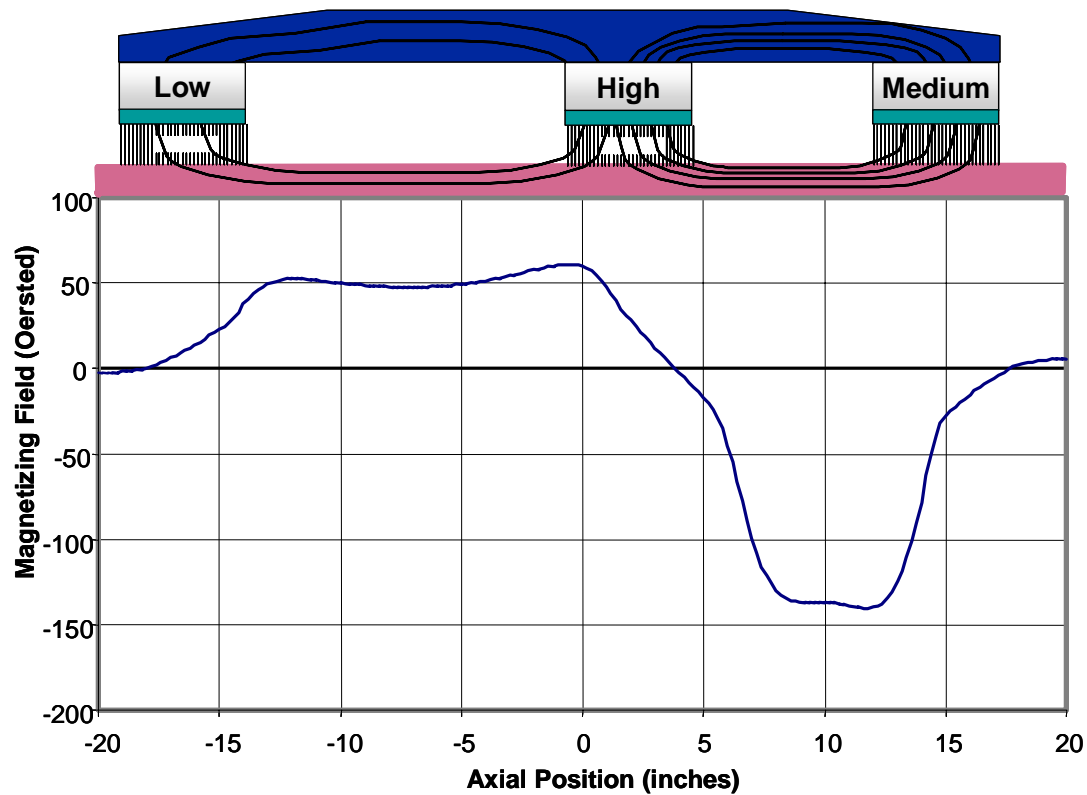
**Figure 3. Model result for a three pole magnetizer implementation of mechanical damage inspection method**

The goal of this project is to establish a simpler more compact magnetizer design that successfully performs a high and low field level inspection. Modeling has begun on various designs that use three magnet poles. A typical result is shown in Figure 3. For this implementation, a strong magnetic pole is in the center, a weak one is at the left and a moderate strength pole is on the right. This result provides the desired field levels for mechanical damage characterization. Additional modeling will be required to examine the many inspection variables such as wall thickness, velocity, pipe diameter, and material properties.
